**OLD YANKEE STADIUM GATE 2 MEMORIAL
ARCHITECTURAL SIGNIFICANCE, CONSTRUCTION,
STABILITY, COST, & ORIGINALITY**

September 21, 2009

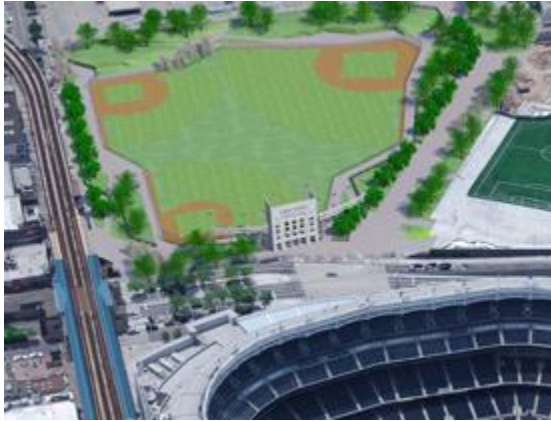
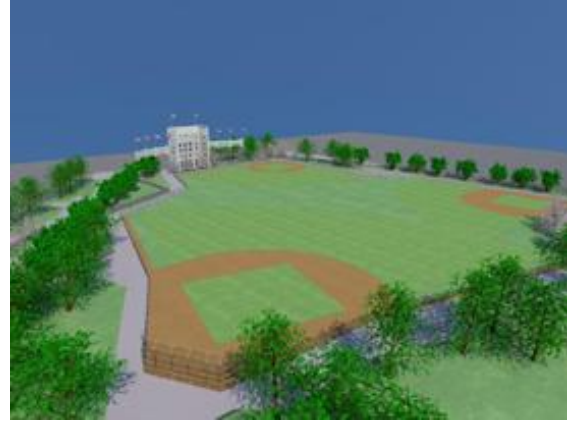
The restored Gate will be a three sided structure with its front side facing north. Connected to this front side on both ends are to be two sidewalls extending to the same height as the Gate's front. The approximate dimensions of the restored Gate 2 as proposed are 68 feet wide, 79 feet high (measured to the 1970s era cornice), and 16-17 feet deep.

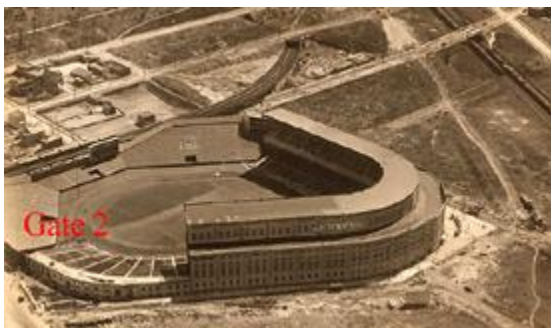
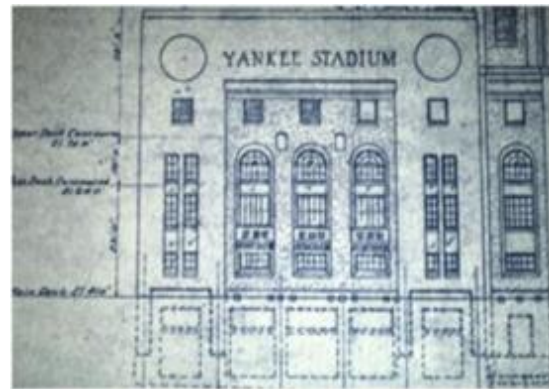
Gate 2 is considered to be the most picturesque section remaining from the original Yankee Stadium dating to the 1920s. On the street level, there are five door openings or bays through which fans entered the Stadium. Three of these are clustered together in the slightly recessed center gate section and the other two are at each end. This portion of Gate 2 was part of the original 1923 Yankee Stadium construction. For the first five seasons, the three level grandstand extended just beyond first and third bases. In the Gate 2 area, only the field level stands originally existed; these were constructed of steel and concrete and were retained throughout the life of the Stadium.

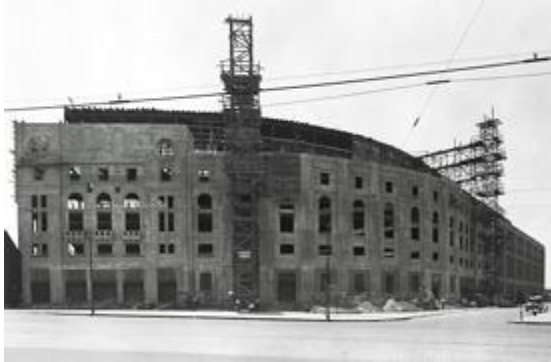
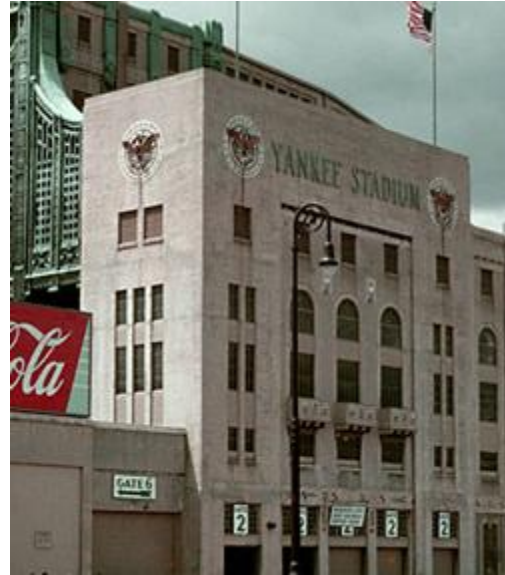
With the expansion of the Stadium grandstand into left field during the 1928 season, the mezzanine and upper levels were built over the existing field level stands. Using the same design as Gate 4 behind home plate, the height of Gate 2 was significantly increased to enclose the corridors and ramps that provided access to these two additional levels of seating. The Gate, as we know it, took shape at this time.

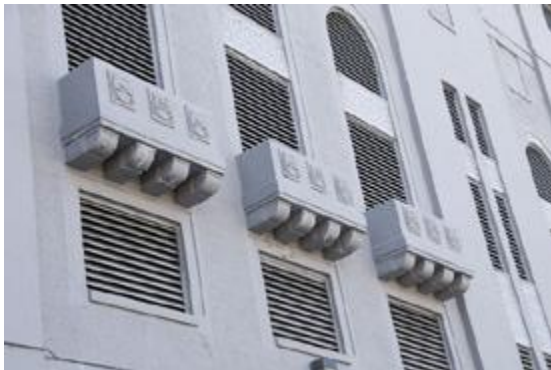
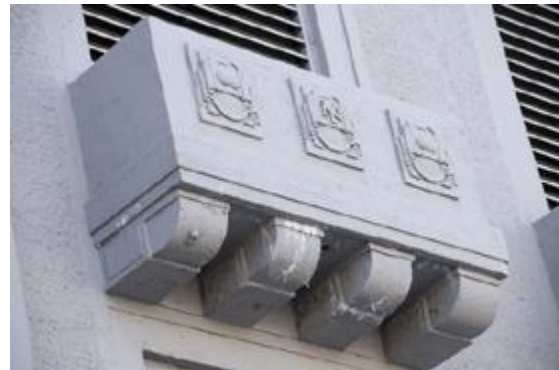
The three attractive arched windows providing light and ventilation for the interior concourses were built as part of this 1928 expansion. The center of this portion of the Gate where these three windows are located is also slightly recessed continuing the configuration of the lowest level of the exterior built in 1923. At about one-third the height of each of these windows were placed small concrete balconies. Nine terracotta “end pylon” pieces with a baseball related motif (baseballs and the Yankees’ interlocking NY logo) were fixed to the balcony fronts (three on each) and two more shields were located above and between the three arched windows. All of this gave Gate 2 symmetry and an imposing and grand appearance.

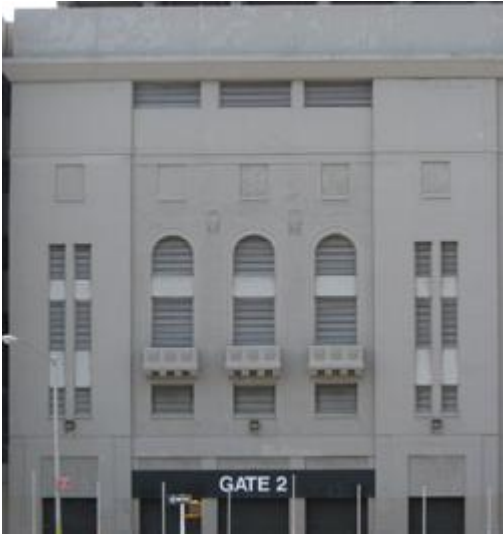
This upper concrete section was cut off during the Stadium renovation and replaced with a similar but taller concrete facade that enclosed the concourse and ramps for the reconfigured upper deck. The replacement concrete section was designed to match the lower Gate 2 structure. One difference with the original is that its lowest section is recessed in the center and follows the contour of the lower Gate. There are three vents for the interior concourse in this center area. A concrete cornice runs horizontally above these vents and across the entire Gate. There is also another flat concrete section above this cornice to complete the current Gate configuration.

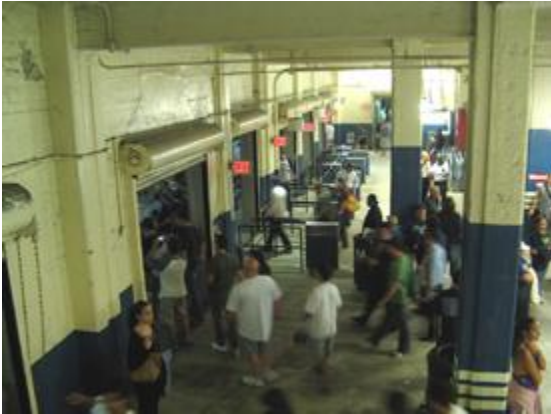
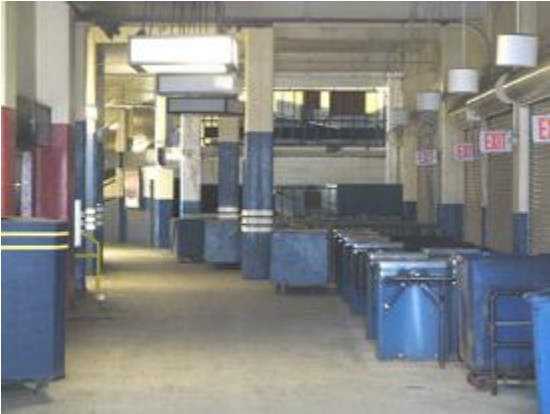
As depicted in the photos above, Gate 2 is connected to a network of structural steel members. These currently support the interior corridors and ramps but provide additional stability for the Gate. Additionally, there is a basement level below Gate 2. Original Stadium plans show the basement depth to be at 10.5 feet below street level.

The Gate 2 structure, along that of the original Yankee Stadium exterior walls, consists of a poured reinforced concrete façade supported by structural steel I-beams. This method of construction is durable as the different structural properties of reinforced concrete and steel compliment each other thus resulting in a very stable building. This was a very common building construction technique during the first half of the twentieth century. It is also rated as fire resistive construction. The upper Gate concrete section dating from the 1970s is also constructed of reinforced concrete.

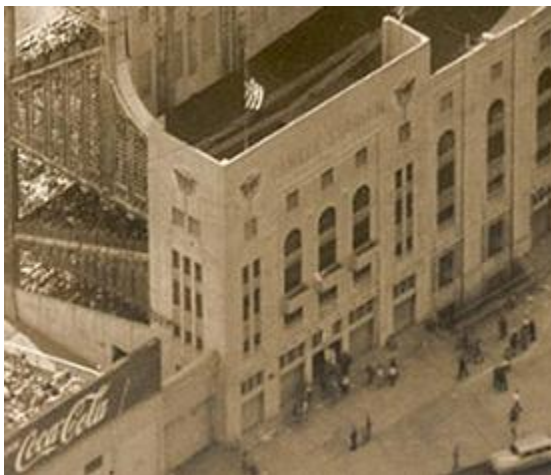
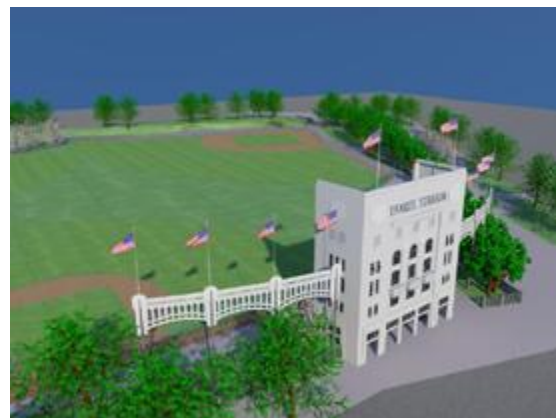
In terms of the necessary Gate 2 restoration needed, our proposal is that the current gate structure be retained up to and including the cornice. This height would be approximately equal to that of the original Gate. The 1970s era concrete section above the cornice would be removed.

With regard to the sidewalls for the completed Gate, the east wall (closest to River Av.) was part of the 1923 and 1928 construction and still exists. The west sidewall would need to be built so as to form the third side of the Gate 2 structure.

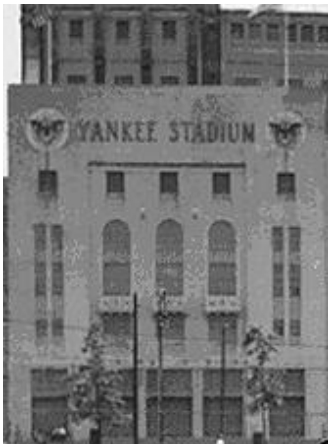
Gate 2: 1928-1973

The bottom section of the Gate was built in 1923 when the Stadium opened. The upper portion (arches & balconies) was added in 1928 with the leftfield grandstand extension. Because the upper deck was reconfigured during the Yankee Stadium renovation in 1973-76, the uppermost section seen in the old photo on the left (contains the two medallions and the Yankee Stadium lettering) was replaced with the concrete strip with the three vent openings and the cornice above as shown in the center post renovation photo. The proposed Gate 2 restoration (depicted at right)

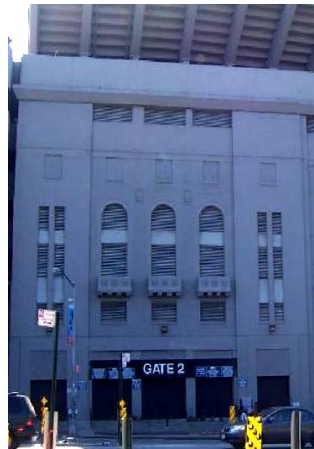
Gate 2: 1976-Current

would involve only the removal of the horizontal concrete strip located above the cornice (refer to center photo) and reinstalling the two medallions and the Yankee Stadium lettering.

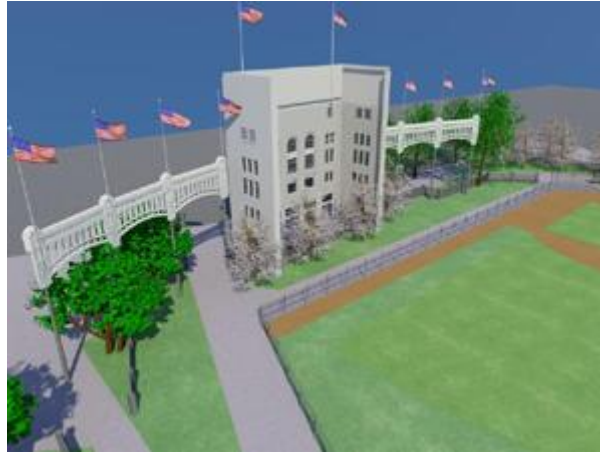
The two sidewalls would provide stability for Gate 2 as shown in the rendering below. The sidewall on the right was built as part of the 1928 grandstand extension. This wall still exists. So new construction would consist of just the one sidewall depicted on the left in this rendering.
